EXPERIENCE THE EXCEPTIONAL

Extending Bearing Life

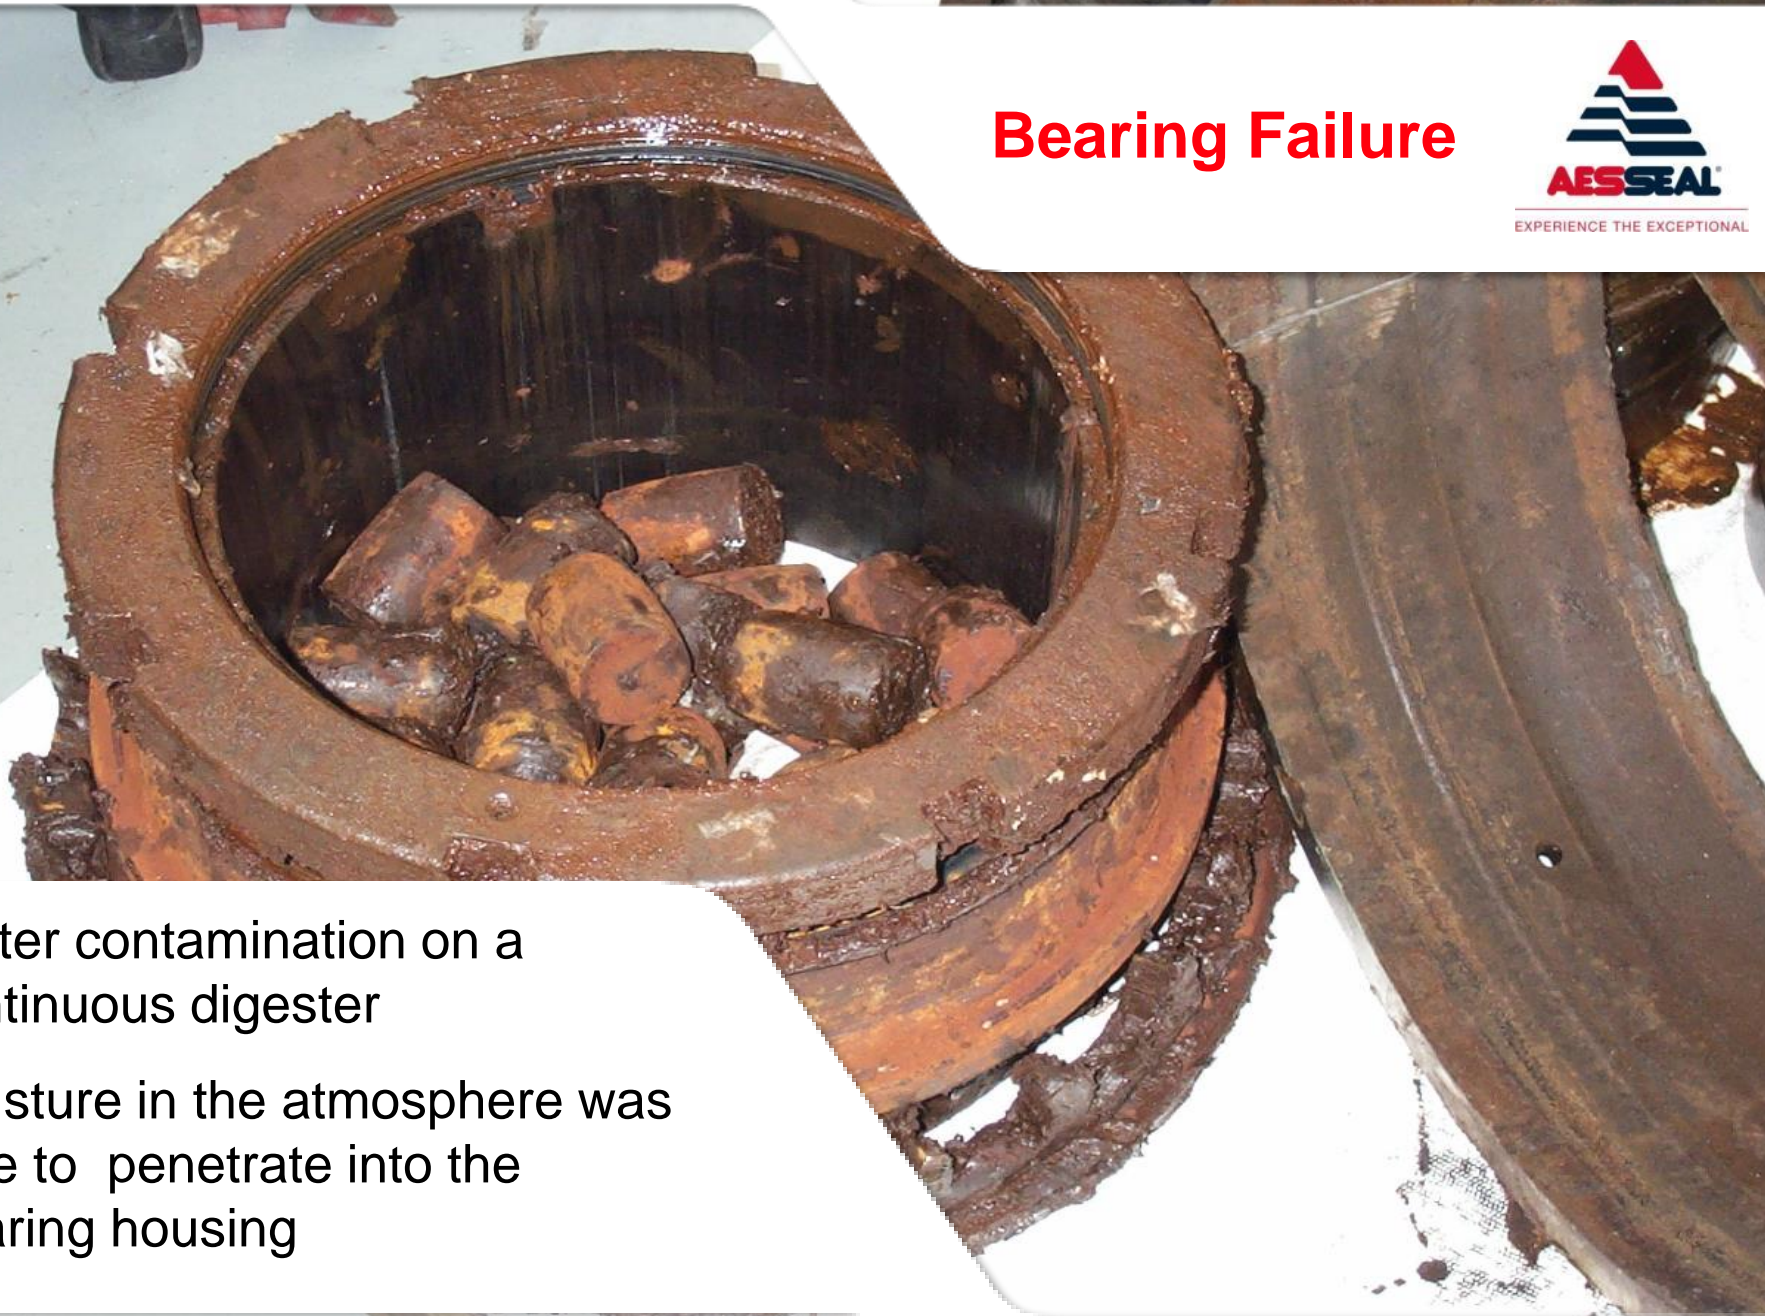
- Water contamination on a continuous digester
- Moisture in the atmosphere was able to penetrate into the bearing housing

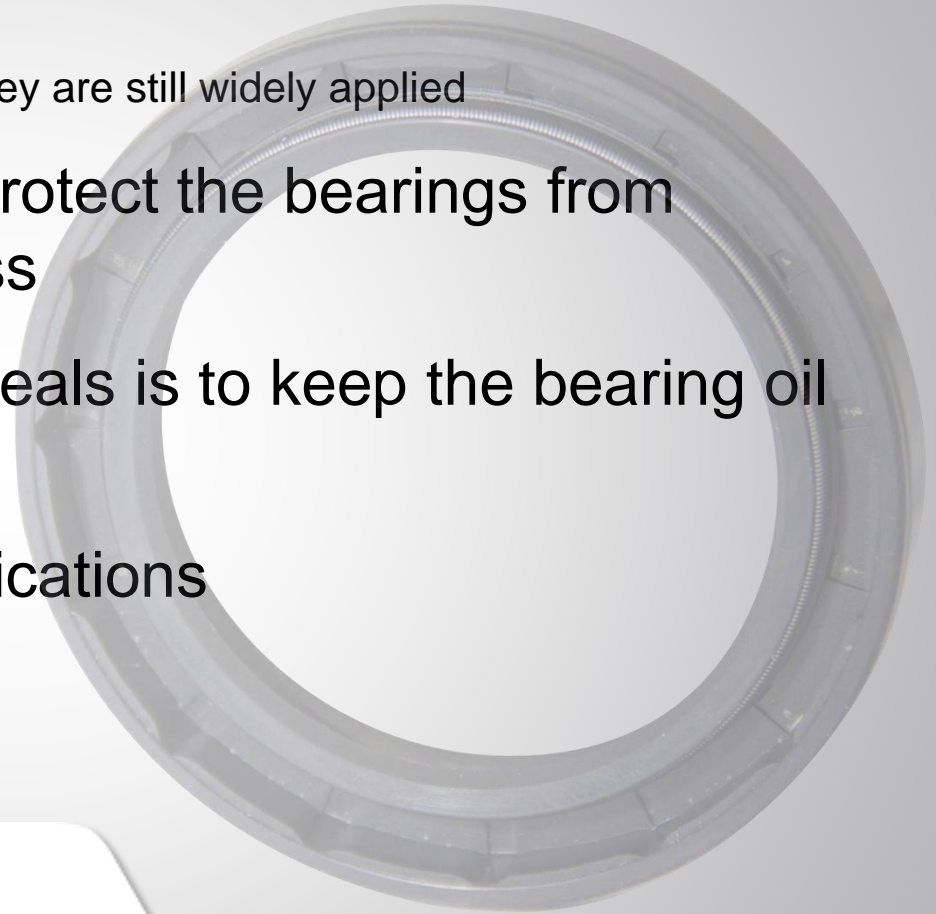
Lip Seals

- The most common method of bearing protection is to use a lip seal
 - Inexpensive initial cost means they are still widely applied
- However they can't fully protect the bearings from moisture or particle ingress
- Main design target of lip seals is to keep the bearing oil in the housing.
- Can't be used in API applications

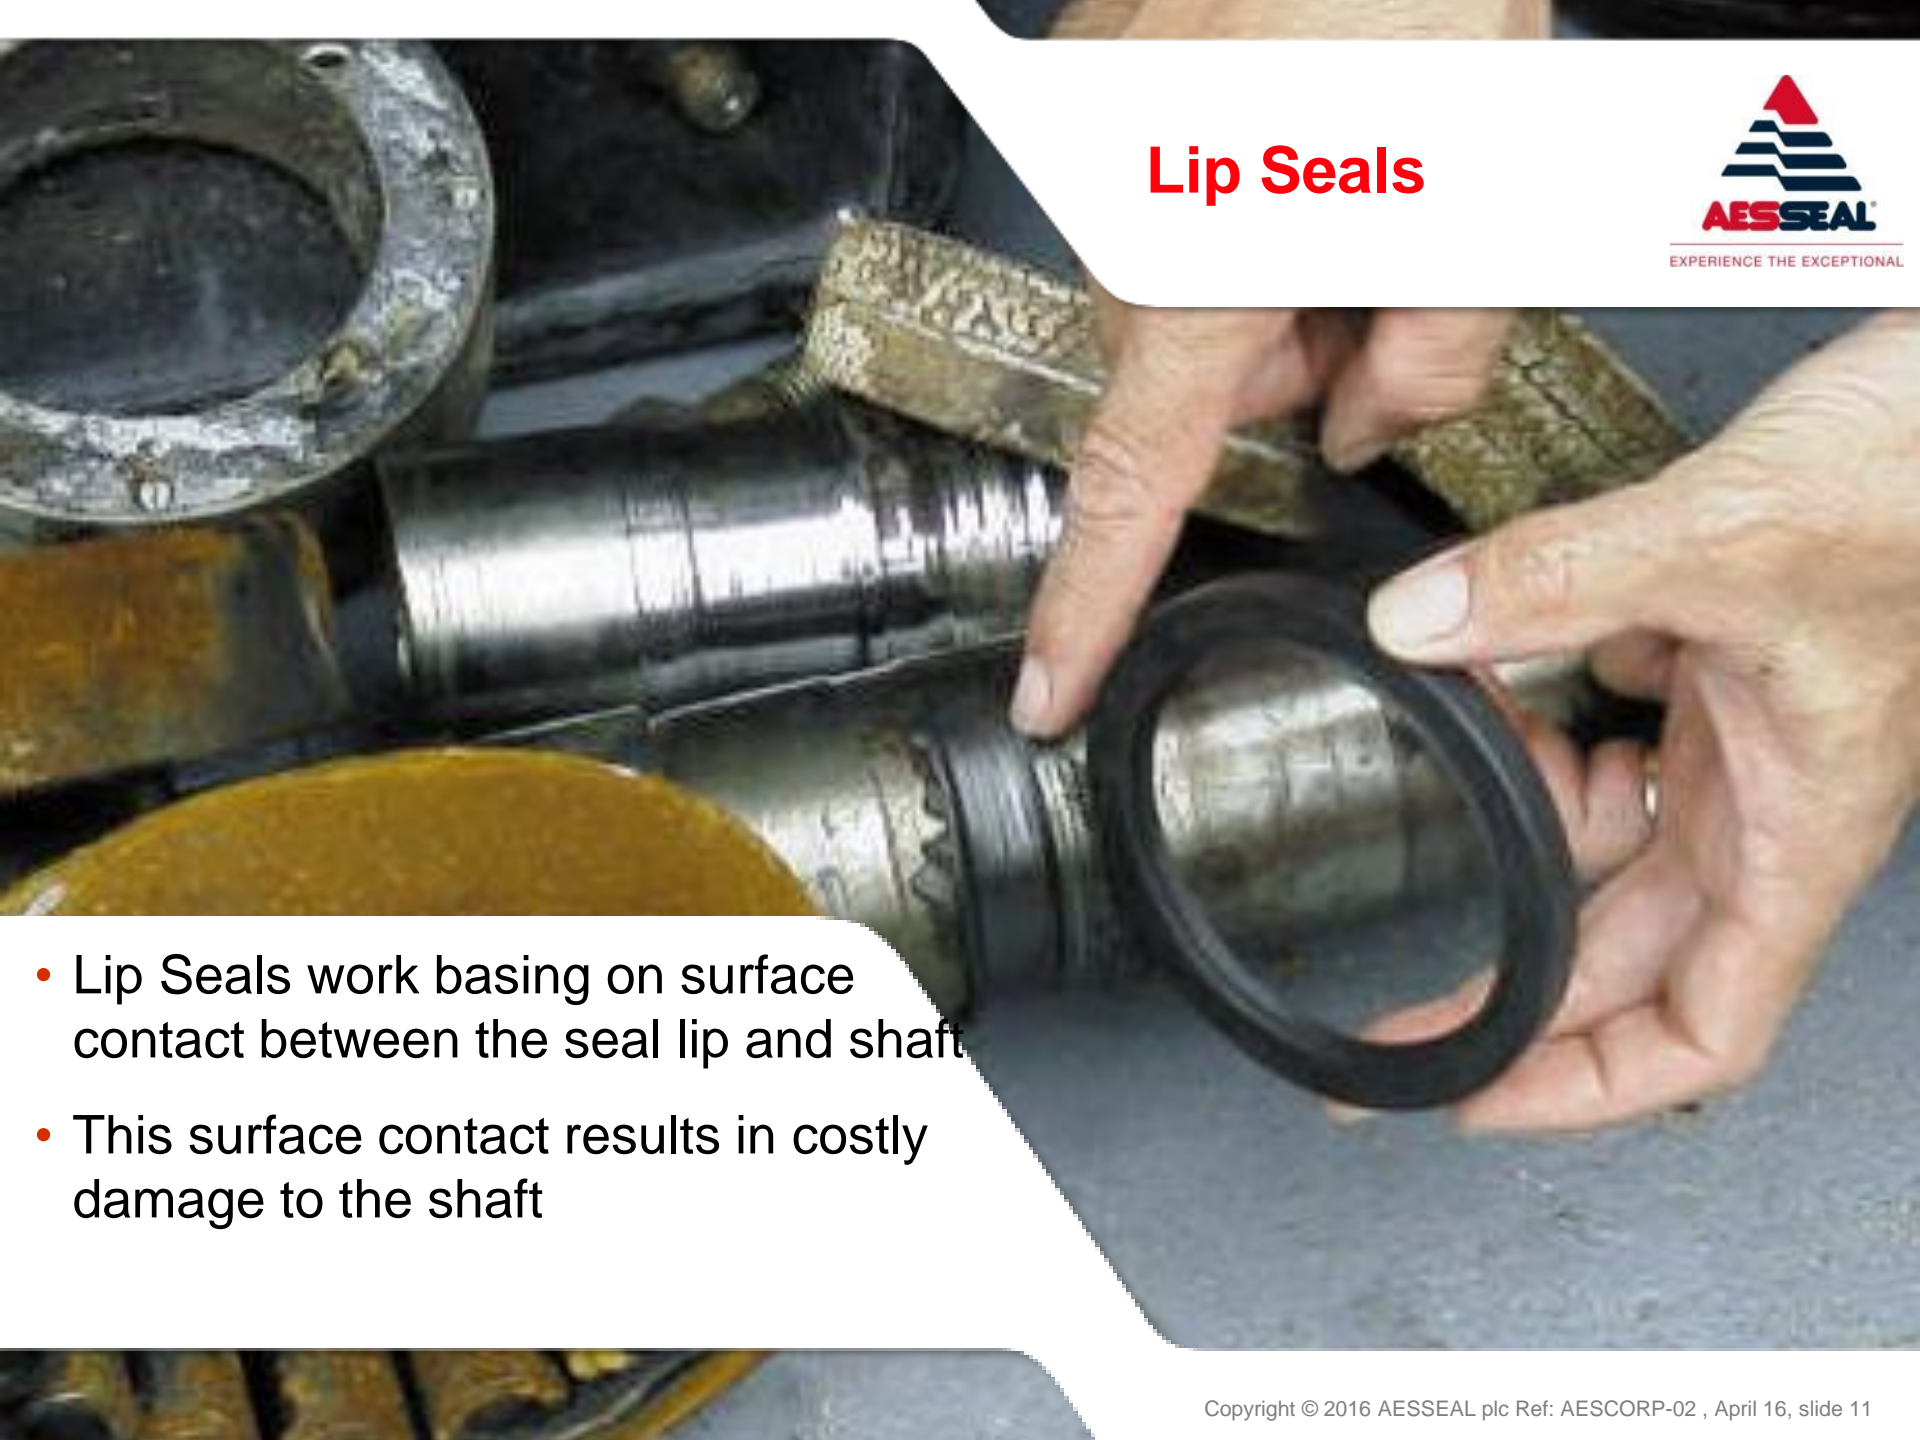
- Lip Seals work basing on surface contact between the seal lip and shaft
 - This surface contact results in costly damage to the shaft

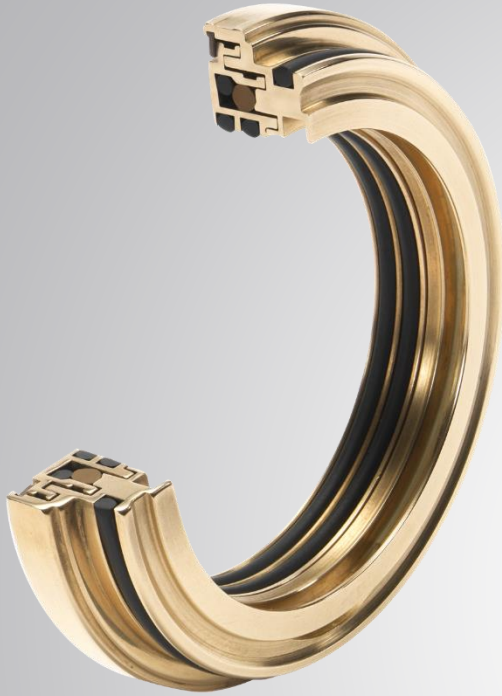
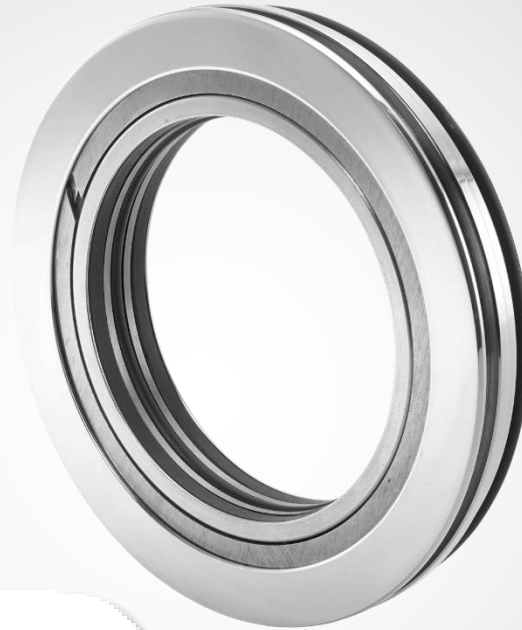
Bearing Protection

- LabTecta successfully eliminates bearing oil contamination
- Suitable for use in pumps, motors, gearboxes, fans & turbines
- Is non contacting in operation

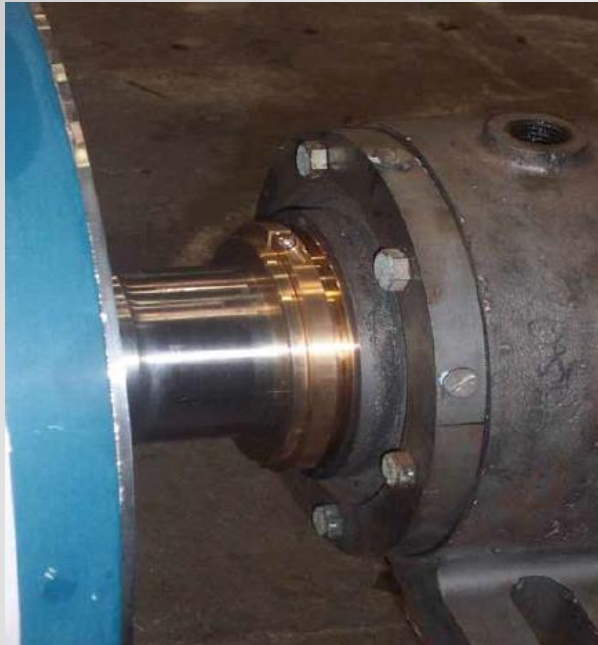
- Water ingress on a customer's machine rolls
- LabTecta-AX can accommodate axial movement of +/- 4.5 mm
- Successfully sealed since 2008

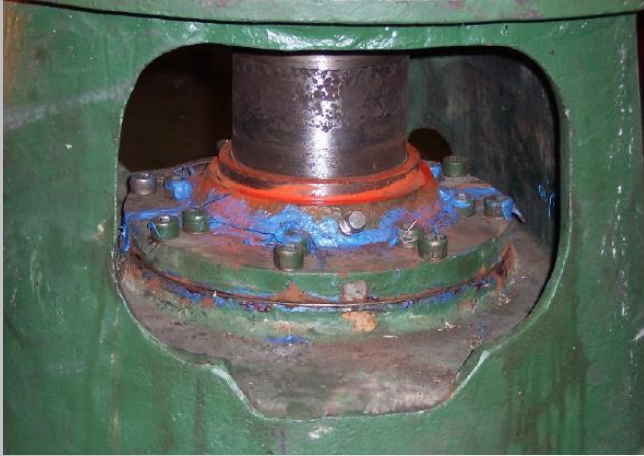
- Paint leaking out of a badly aligned bottom entry mixer. Motor damaged every two month.
- LabTecta ® TE installed in 2006 & still working today

- MTBF increased by 500%
- Saving €6000 per year in maintenance cost.
- Saves 9.5 days per year in lost production.
